INSPECTION REPORT

1234 Main Street Bolton, ON L7E0N4

Buyer Name 01/26/2023 9:00AM

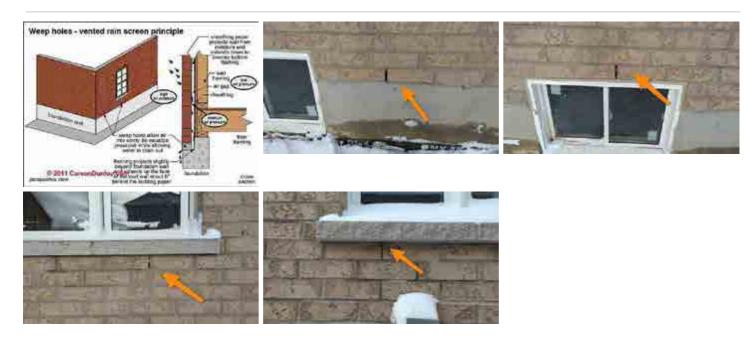
OBC - WEEP HOLES ARE MISSING OR PARTIALLY CLOSED

REPRESENTATIVE PICTURES Weep holes are required at this location as per OBC.

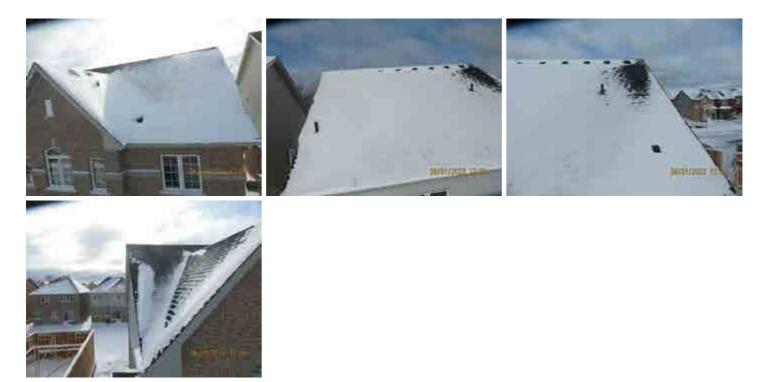
WEATHER LIMITATIONS

The snow cover limits the inspection of the roof and its components. Any comments reflect the parts of the roof that are visible, if any.

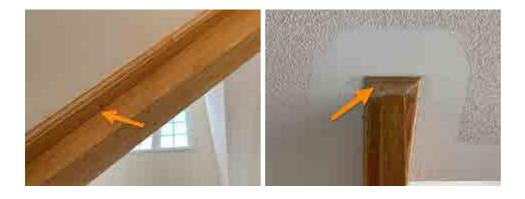
Nailheads and fasteners shall not protrude above the surface. Where nailheads and fasteners have been set below the surface they shall be filled with compatible filler unless designed otherwise. Filler may be noticeable under normal lighting conditions.

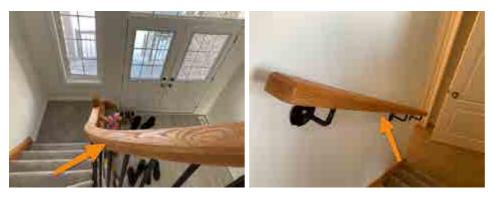
11.5.2 Staircase/Railing

UNFISHED AND ROUGH HANDRAIL

The top and bottom stairwells are not finished or stained, Recommend fixing all nicks, unfilled holes, sanding leftover wood filler, sand and finishing all wood sections of stairwells in the home.

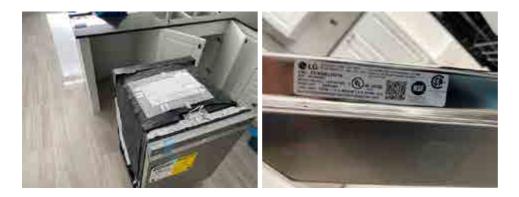
APPLIANCES ARE NOT INSTALLED

Recommend testing once plumbing and electrical are installed.

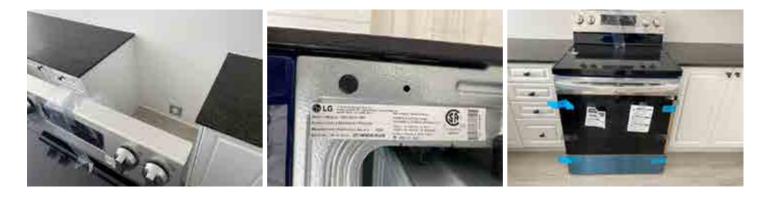
Oven/Stove

THE STOVE IS NOT INSTALLED/PLUGGED IN

Recommend testing once plugged in and installed

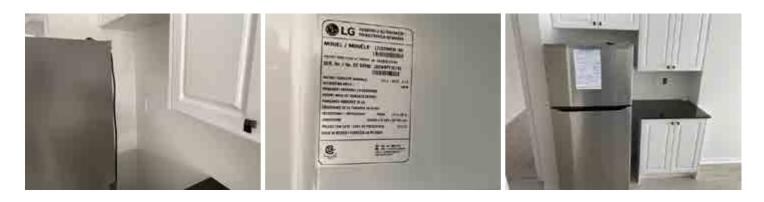
Refrigeration

THE REFRIGERATOR WAS NOT PLUGGED IN TO ITS RECEPTACLE THEREFORE IT WAS NOT INSPECTED

Receptacle tested fine for the fridge, recommend testing fridge once plugged in.

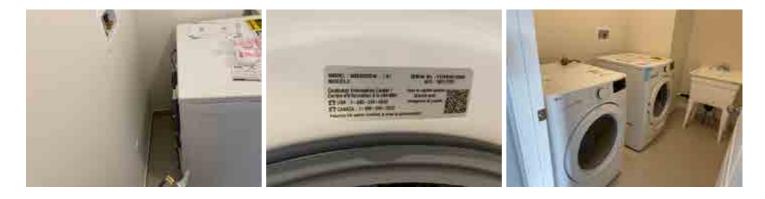
Laundry

THE WASHER WAS DISCONNECTED AT THE TIME OF THE INSPECTION

Please note the shipping bolts are still installed at the time of the inspection. Review manufacture instructions, remove bolts and test once installed.

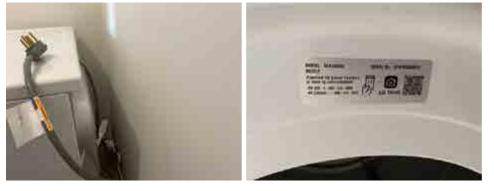
Laundry

THE DRYER WAS DISCONNECTED AT THE TIME OF THE INSPECTION
